ERDC/CHL TR-04-3

**Demonstration Project on Dredging
and Marsh Development Using a Flexible-
Discharge Dustpan Dredge at Head
of Passes/Southwest Pass Mississippi River**

Final report

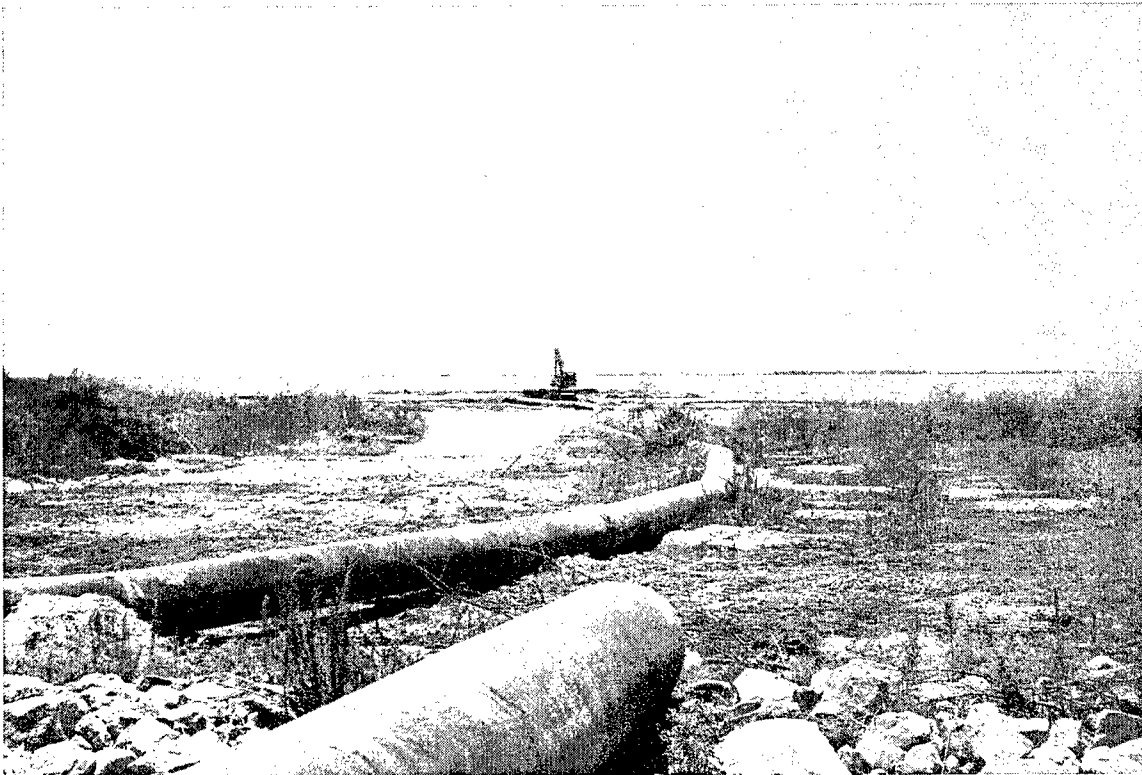
Photo 14. Discharge pipe across dike, pasture land, and existing wetlands

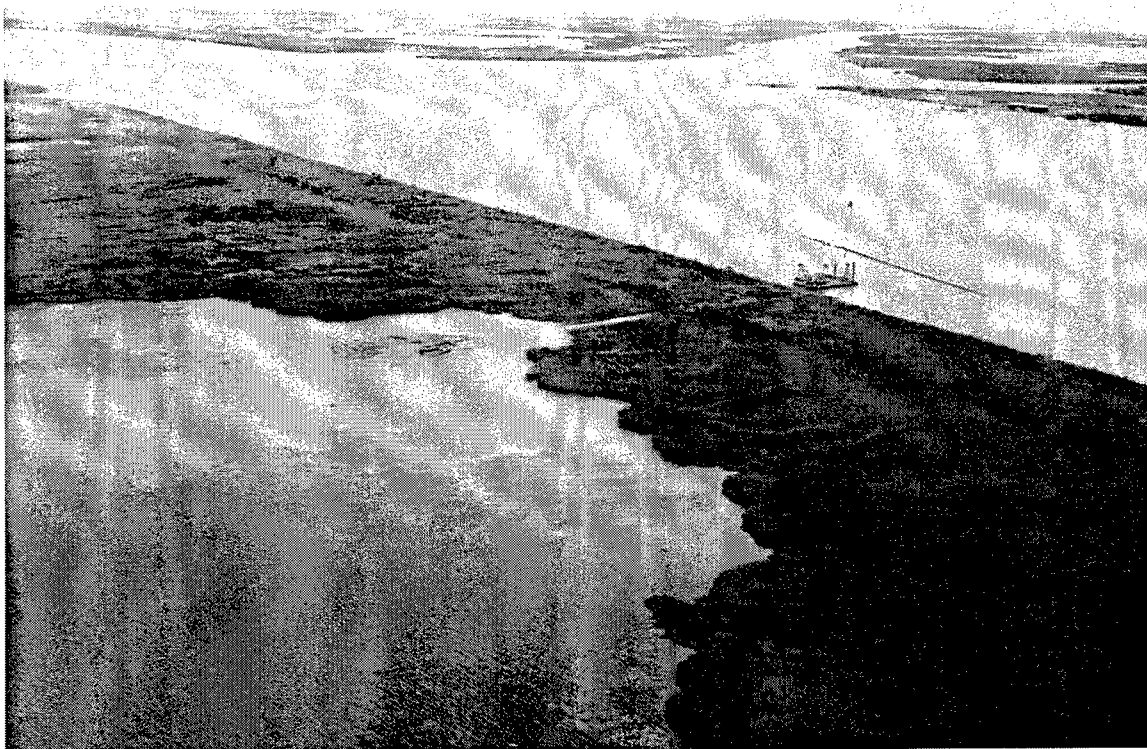
Photo 29. Before dredging aerial photo of placement site

Photographs of the BD and AD placement site are shown in Photos 29 and 30, respectively. BD and AD placement site surveys were conducted by the contractor's survey crew and inspected by MVN, using airboats, mobile DGPS for horizontal positioning, and spirit leveling for vertical control. The results from these surveys are plotted on Figures 11 and 12 (BD and AD surveys, respectively). The difference plot between the BD and AD surveys is shown in Figure 13. The dredged material deposit's footprint covers an area of approximately 20 acres. From the surveys, the contractor calculated a deposition volume of 177,700 cu yd. Assuming a 20 percent loss in fines in runoff, this volume was adjusted up to a gross volume of 222,000 cu yd. Contract specifications required that no dredged material exceed a vertical placement height of +3.5 ft MLG, but Figure 12 (referenced to the MLG datum) indicates elevations that exceed +3.5 ft. This resulted from the impact of an inspection conducted 13 June of the placement area, when USACE and OAS personnel discovered several least tern and American avocet nests containing eggs (Photo 31). The nests had been constructed some distance from the active placement point and were not being disturbed, but MVN decided to terminate the grading operations, along with the dredging operations, at 2100 hr on 13 June to preclude any damage to the nests. This rapid colonization by the least terns and American avocets, as well as other species, is an aspect that should be considered for future dredging projects of a similar nature.

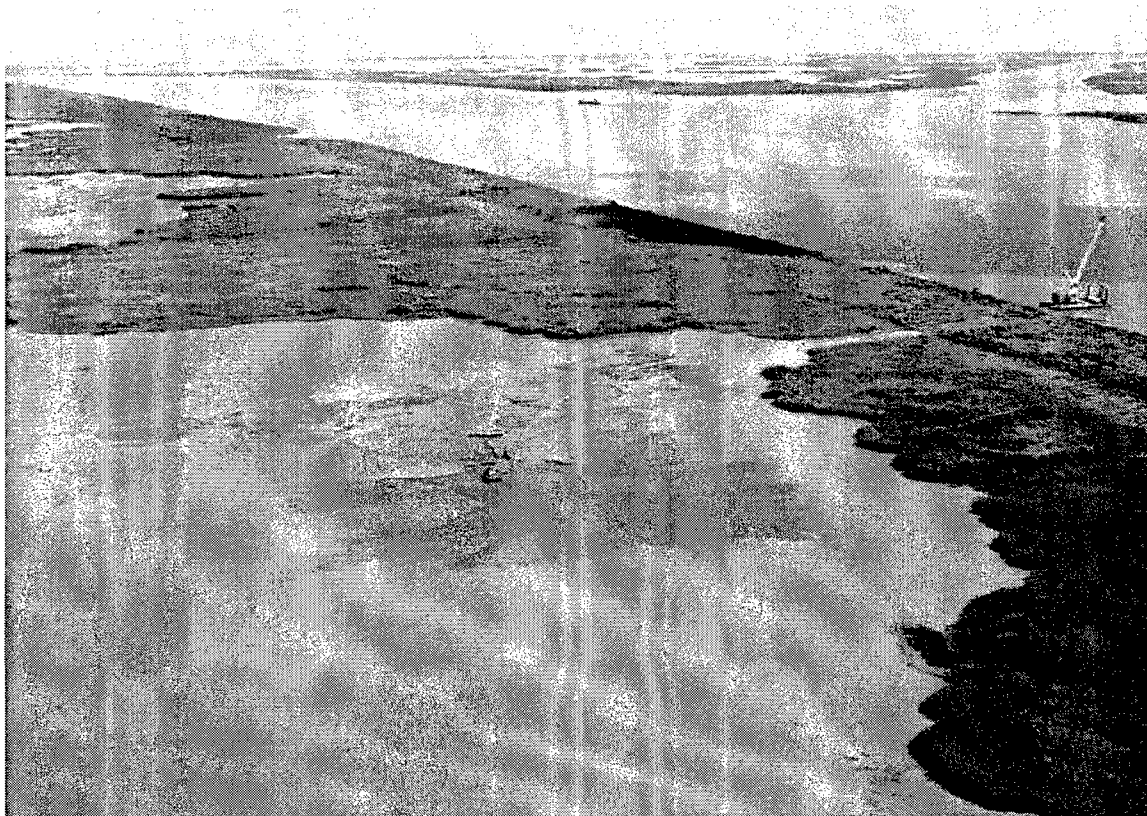
Photo 30. After dredging aerial photo of placement site
